## A Decade After the 2004 Indian Ocean Tsunami: The Progress in Disaster Preparedness and Future Challenges in Indonesia, Sri Lanka, Thailand and the Maldives

**Abstract**—The 2004 Indian Ocean tsunami was one of the most devastating tsunamis in world history. The tsunami caused damage to most of the Asian and other countries bordering the Indian Ocean. After a decade, reconstruction has been completed with different levels of tsunami countermeasures in most areas; however, some land use planning using probabilistic tsunami hazard maps and vulnerabilities should be addressed to prepare for future tsunamis. Examples of early-stage reconstruction are herein provided alongside a summary of some of the major tsunamis that have occurred since 2004, revealing the tsunami countermeasures established during the reconstruction period. Our primary objective is to report on and discuss the vulnerabilities found during our field visits to the tsunami-affected countries—namely, Indonesia, Sri Lanka, Thailand and the Maldives. For each country, future challenges based on current tsunami countermeasures, such as land use planning, warning systems, evacuation facilities, disaster education and d

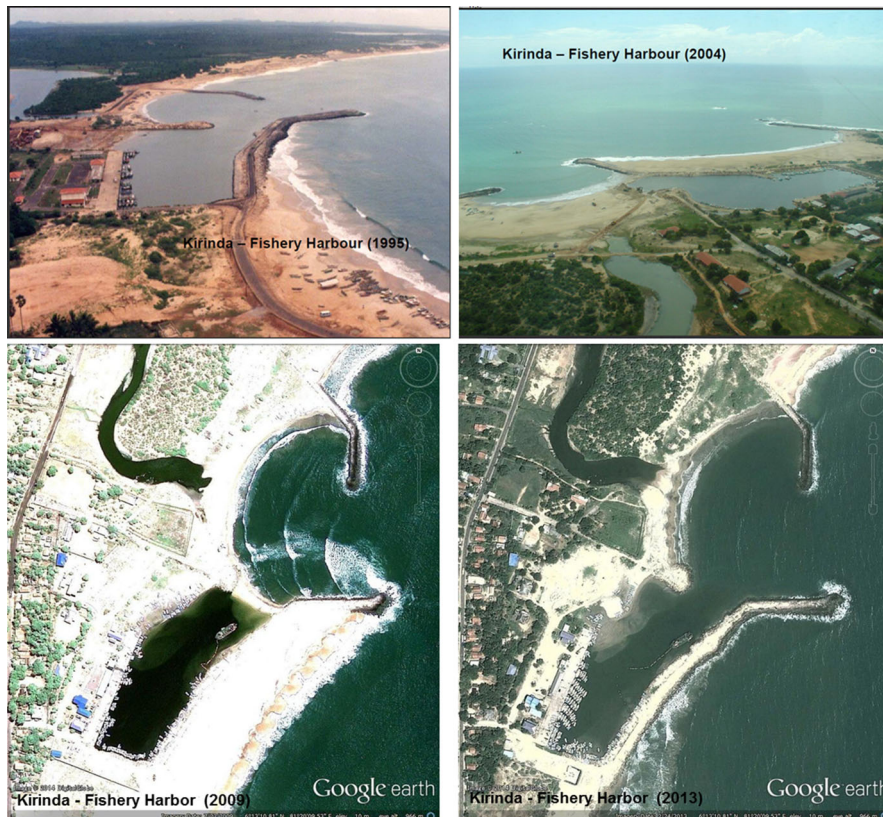
Figure 6

Bathymetric changes in the Kirinda fishery harbor in 1995, 2004, 2009 and 2013. [Image source: Lanka Hydraulic Institute Ltd (LHI) and Google earth]

The damage the Indian Ocean tsunami caused to coastal infrastructure, ecosystems and the fishery sector was significant. Nearly 80 % of fishing boats and ten out of the twelve fishery harbors were badly damaged (CH2MHill 2006). Hikkaduwa, Mirissa, Galle, Puranawella, Hambantota and Kirinda are harbors that were considered highly damaged due to the tsunami. The Kirinda fishery harbor is a good example of engineering projects that mitigate natural phenomena. After its initial construction, the harbor faced a serious problem in 1992: sand accumulation blocked the harbor entrance. Some civil engineering projects, such as dredging and the construction of new breakwaters, were introduced to solve the problem, but the problem continued until before the 2004 tsunami occurred (Fig. 6). The Kirinda fishery harbor was severely affected by the 2004 Indian Ocean tsunami in terms of both coastal structures and coastal morphology (e.g., GOTO *et al.* 2011; RANASINGHE *et al.* 2013). During the tsunami, an approximately 8-m-high tsunami flood was recorded, and a large dredging ship called the *Weligowwa* was cast ashore. Because of the sand blockage, bathymetric change was being measured in

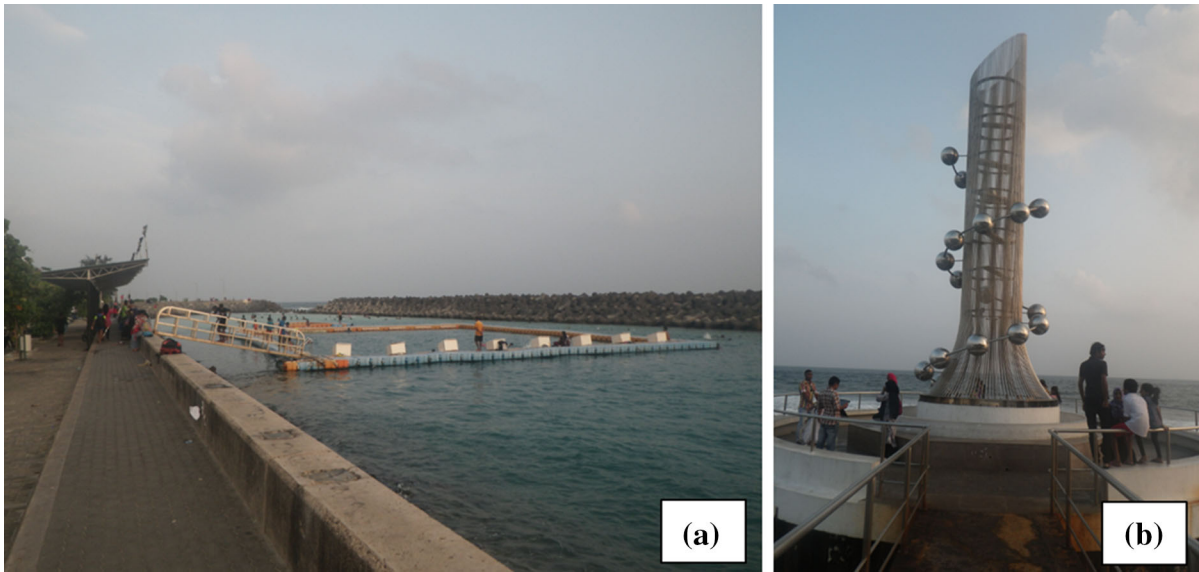
Figure 17  
**a** Seawall and breakwater in the south of Male and **b** memorial statue of the 2004 Indian Ocean tsunami in Male

Male, the capital city (Fig. 16), with an area of  $1 \times 2 \text{ km}^2$ , was the main target area for our official visits. The city was protected during the 1990s by seawalls and breakwaters (Fig. 17a) that were built before the 2004 tsunami; however, measures for supporting evacuation during future tsunamis were not observed. Unlike in Indonesia, Sri Lanka and Thailand, there were no tsunami-related signs to provide information on the tsunami hazard zone, the tsunami height, evacuation routes or evacuation buildings. On the 9-year anniversary of the tsunami (26 December 2013), there were no major events in Male except several news reports, but there were some small events on other islands. There was no sign indicating the tsunami memorial monument shown in Fig. 17b. This picture was taken on the anniversary, and the monument was no busier than on other days. The main road along the shoreline, which links the entire city, is a one-way street, similar to the roads in Patong beach in Phuket, Thailand. The two-lane road is always crowded with parked cars and motorcycles that could obstruct evacuation (Fig. 18a, b). The small streets that link the main road to the inland are narrow and obstructed by many objects on the ground. In addition, although most buildings along the shoreline have at least two stories, there are no signs indicating tsunami evacuation shelters. The coast guard building and other government buildings near the shoreline could be used as evacuation buildings.

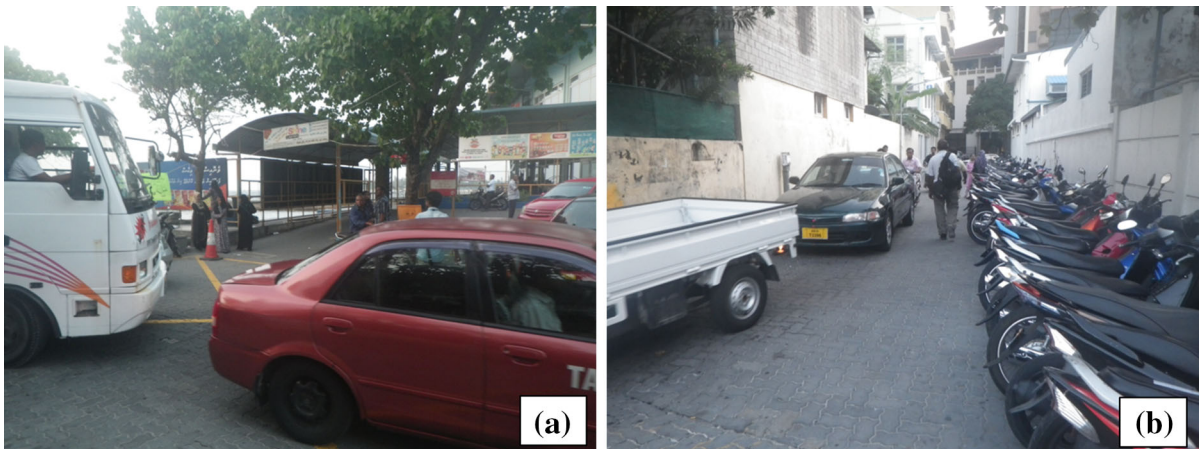
Figure 18  
**a** Crowded traffic during rush hour in the road along the coast and **b** an evacuation route that is blocked by parked motorcycles
