# Report on Site Visit to Japan (19-25 October 2008)

by Djoko Luknanto<sup>1</sup>

Collaboration project on monitoring methods of archeological monuments have been carried out between National Research Institute for Cultural Properties, Tokyo (NRICPT), Japan and Borobudur Heritage Conservation Office (BHCO), Indonesia. The collaboration aims to share and exchange knowledge, expertise and experience of monitoring methods of monuments.

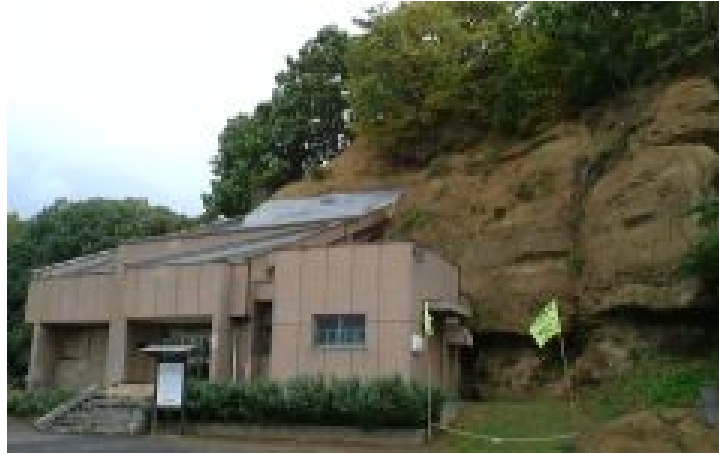
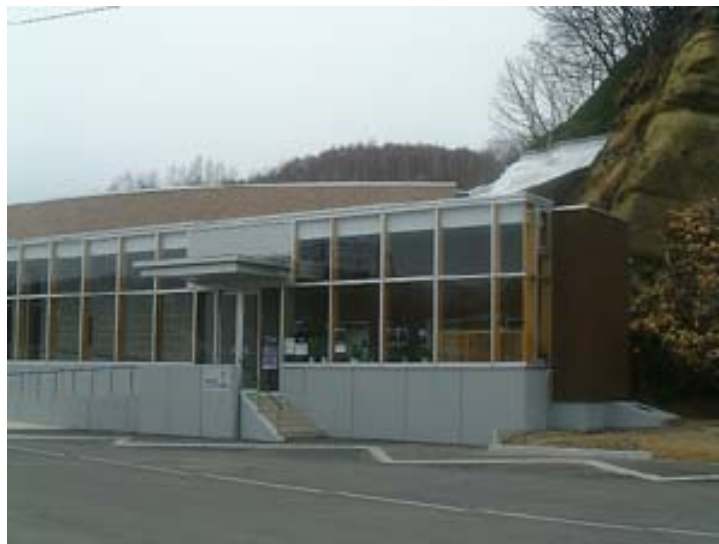
Visitors to the Fugoppe cave cannot see the original opening from the surrounding. The Fugoppe office was built in front of the cave (see Figure 2). The office served the purpose for (1) protecting the cave from the detrimental effect of visitors and weather, (2) for giving information to visitors, (3) the place for monitoring equipments. The office itself has been renovated several times.

Figure 2. The old and new office building of the Fugoppe Cave  
(<http://www.amateras.com/trip/japan/hokkaido/otaru-e.htm>)

- Due to weather and some physical considerations, both caves are surrounded by the modern building to accomodate all the necessary monitoring and protection scenarios, therefore the originality of the cave opening cannot be found anymore by visitors. In the future, it might be important to take the balanced consideration between preserving the originality of the cave opening (conservation aspect) and the protection/monitoring of the caves. In Indonesia, for comparison, there are many caves that has the prehistorical paintings. Some of the found in Maros and Pangkep areas. In this case, the opposite situation happened. The cave is still in the original state, but the monitoring and protection aspect a bit more difficult to carry out (see Figure 11).

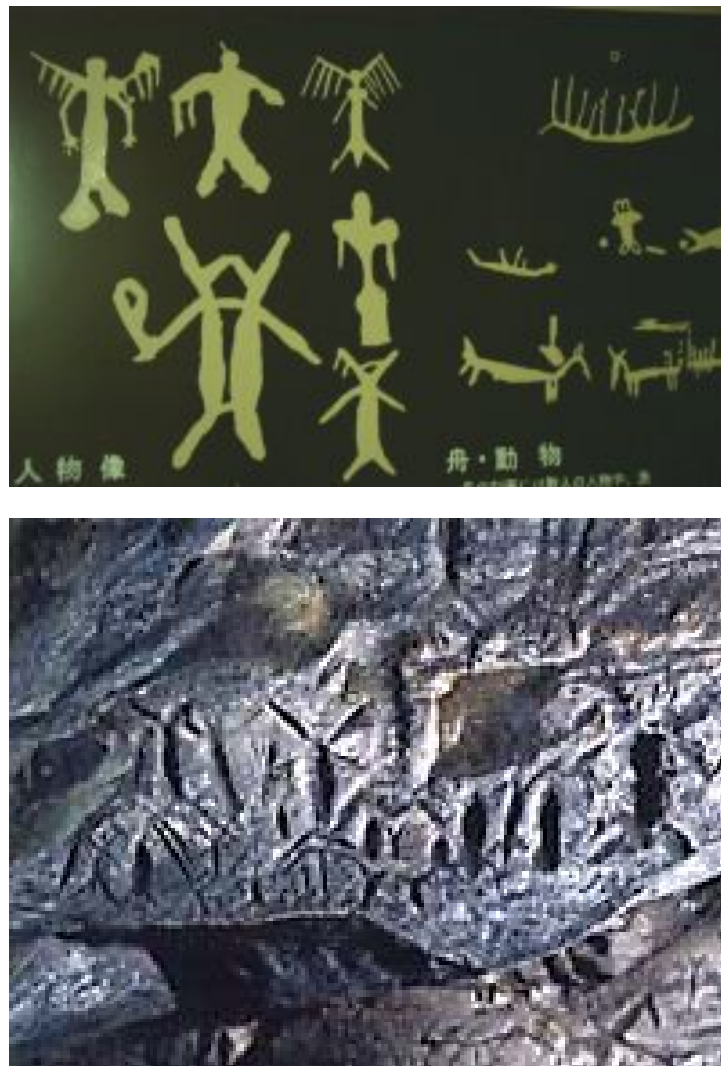
The walls are covered by 2,000 years old engravings showing mostly human figures. Some of them have wings and look like angels. They belongs to the history of Post-Jomon Period, about 1500 years ago. (See Figure 3).

Figure 3. The reproduction (above) and the original painting on the cave wall  
(Photo Courtesy of Yoichi Town Board of Education, Hokkaido)

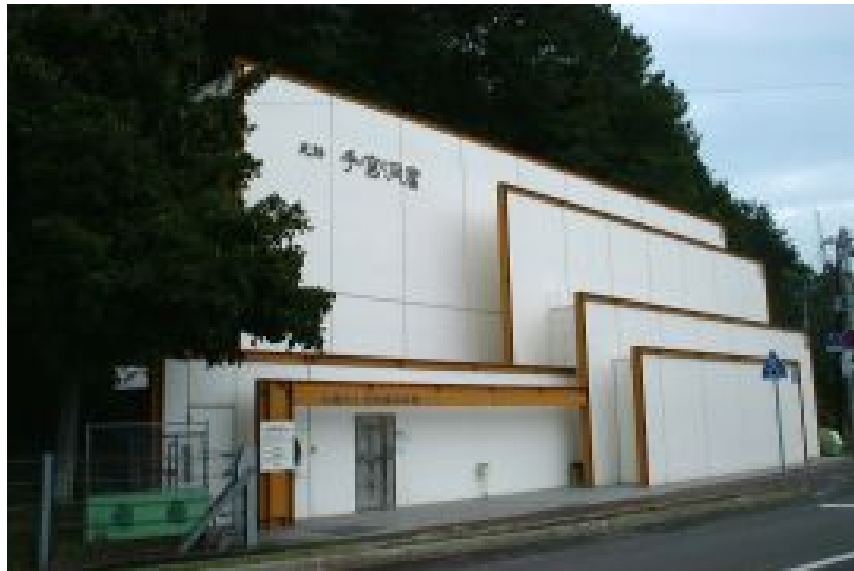
Figure 4. Temiya Cave Office  
(<http://www.amateras.com/trip/japan/hokkaido/otaru-e.htm>)

Temiya cave situated at the foot of small hill and also very close to the highway (see Figure 5). This cave is the first cave in Japan that has been designed and monitored with very sophisticated monitoring devices. The office equipped with very interesting video information for visitors. This information is not found in the latter developed cave office, the Fugoppe's. The monitoring devices are less sophisticated than the devices installed at Fugoppe office. At Temiya office, the daily monitoring is still recorded automatically with the roll paper; not directly connected to the computer chip. Even with the old fashioned monitoring equipments, as seen at Tamiya Cave, it is quite expensive, and it is difficult to be adopted to other less develop countries.

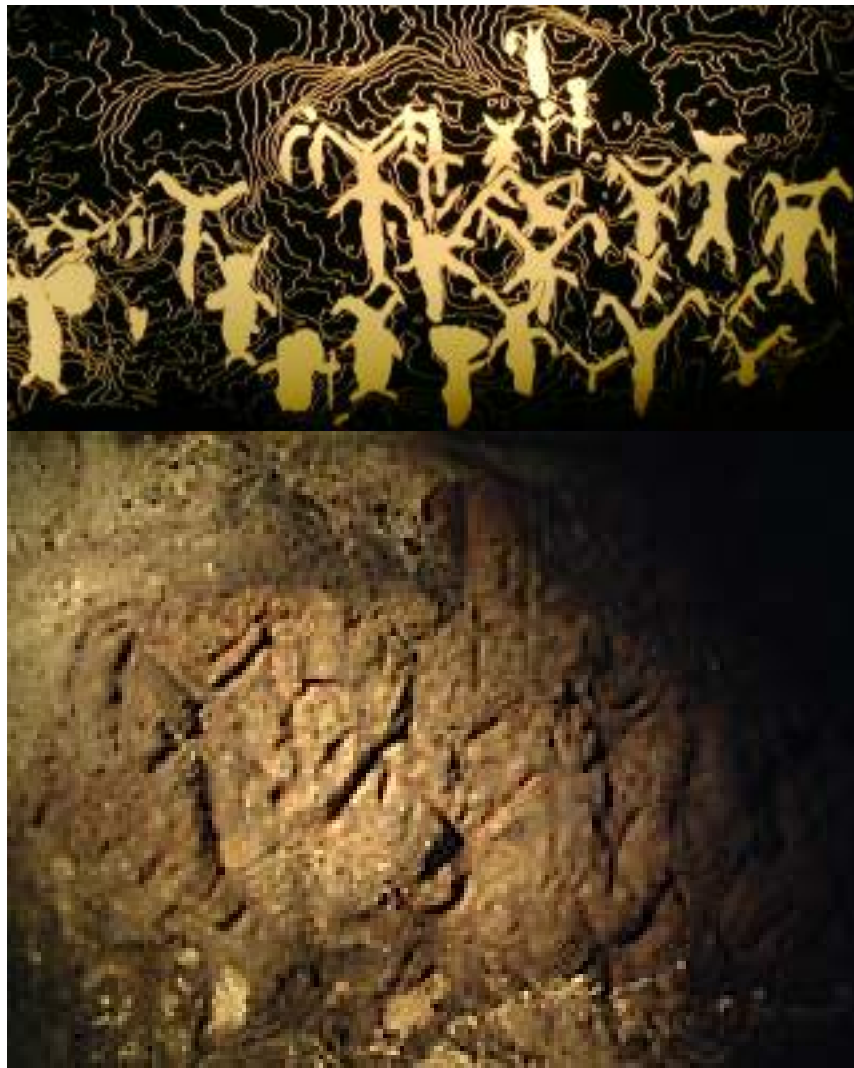
Temiya Cave is only a small remains of a cave, which is of great archaeological interest. It contains cave carvings and Inkoku paintings from the Zoku-Joumon period of Ainu history, about 400 AD (see Figure 5).

Figure 5. The reproduction (above) and original (below) Temiya Cave painting  
(Photo Courtesy of Yoichi Town Board of Education, Hokkaido)

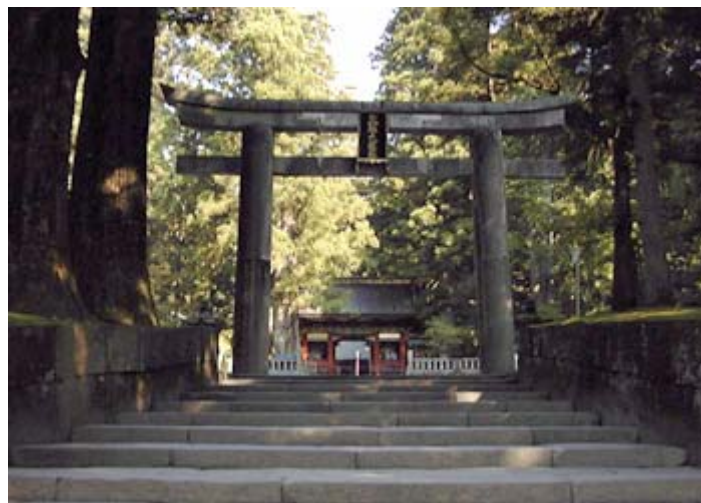
The Ishidorii has remained in its original form since its construction in 1618. The torii gate, which is 9.2 m tall and 13.2 m wide, is made out of 15 blocks of stone, instead of wood, which is the material usually used for torii (see Figure 6).

Figure 6. The Ishidorii, a torii gate, constructed from stones (<http://www.city.nikko.lg.jp/kankou/shaji/english/main.htm>)

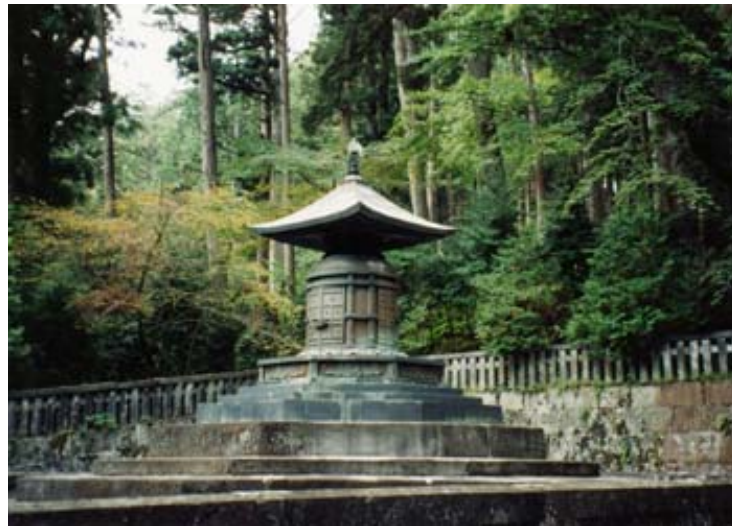
The Okusha Hoto was originally a wooden building when first constructed in 1622, but was remodeled into a stone structure in 1641. The bronze pagoda, which we see now, is a 1683 reconstruction, built after an earthquake destroyed the stone building (see Figure 7).

Figure 7. The Okusha Hoto, bronze pagoda, is a 1683 reconstruction (<http://www.city.nikko.lg.jp/kankou/shaji/english/main.htm>)

- During the visit to the Hokusai Hoto (see Figure 7), it was found that the interlocking between two stone blocks was replaced by a bronze lock. Due to the oxidation between metal (bronze) and the surrounding air, the bronze lock was deteriorated. In this case, it is much better to use stone to make the lock. At Borobudur World Heritage Site, this kind of lock is always used, since it is more natural to the surrounding stone blocks (see Figure 12).

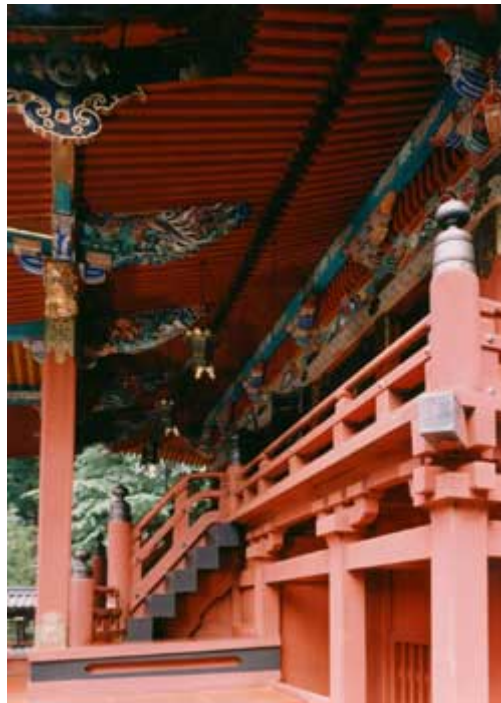
The Honden was originally constructed in 1619 as the main hall of Futarasan-jinja. It was relocated from its original location to the present location when a couple of accompanying halls were added in 1645. Though some replacement of materials has been done for maintenance purposes involving roofing, painting and decorative metal fittings, no changes have been made as far as structural members are concerned (see Figure 8).

Figure 8. The Honden, the main hall of Futarasan-jinja (mainly constructed from wood) (<http://www.city.nikko.lg.jp/kankou/shaji/english/main.htm>)

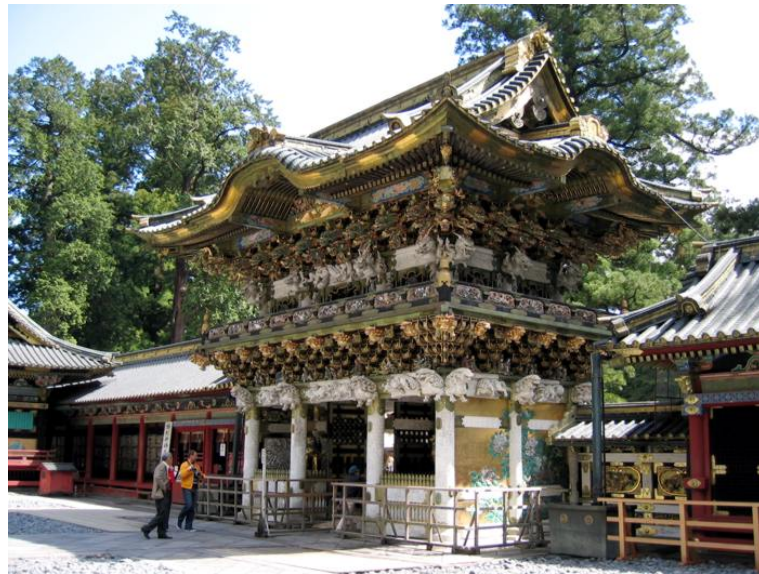
One of the famous gate found in the site are the Nikko gate, which is highly ornamental with very bright coloring style (Figure 9). This style of ornaments as well as its bright coloring was found all over the place. Like any other ornaments found in the sites, there are story attached to the related ornament. One famous ornament is depicted by three monkeys closing their ears, mouth, and eyes to deliver the famous old teaching “Hear no evil, speak no evil, see no evil” (see Figure 10).

Figure 9. Nikko Gate

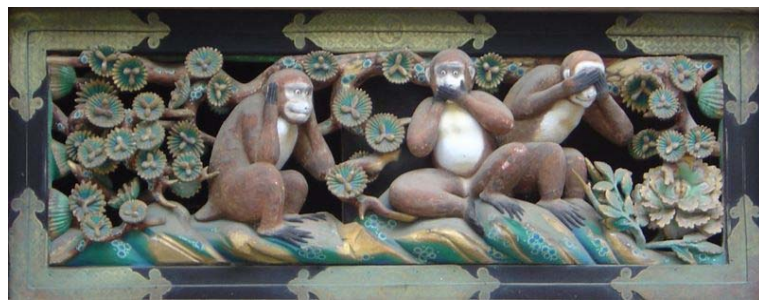
Figure 10. Hear no evil, speak no evil, see no evil (Toshogu)

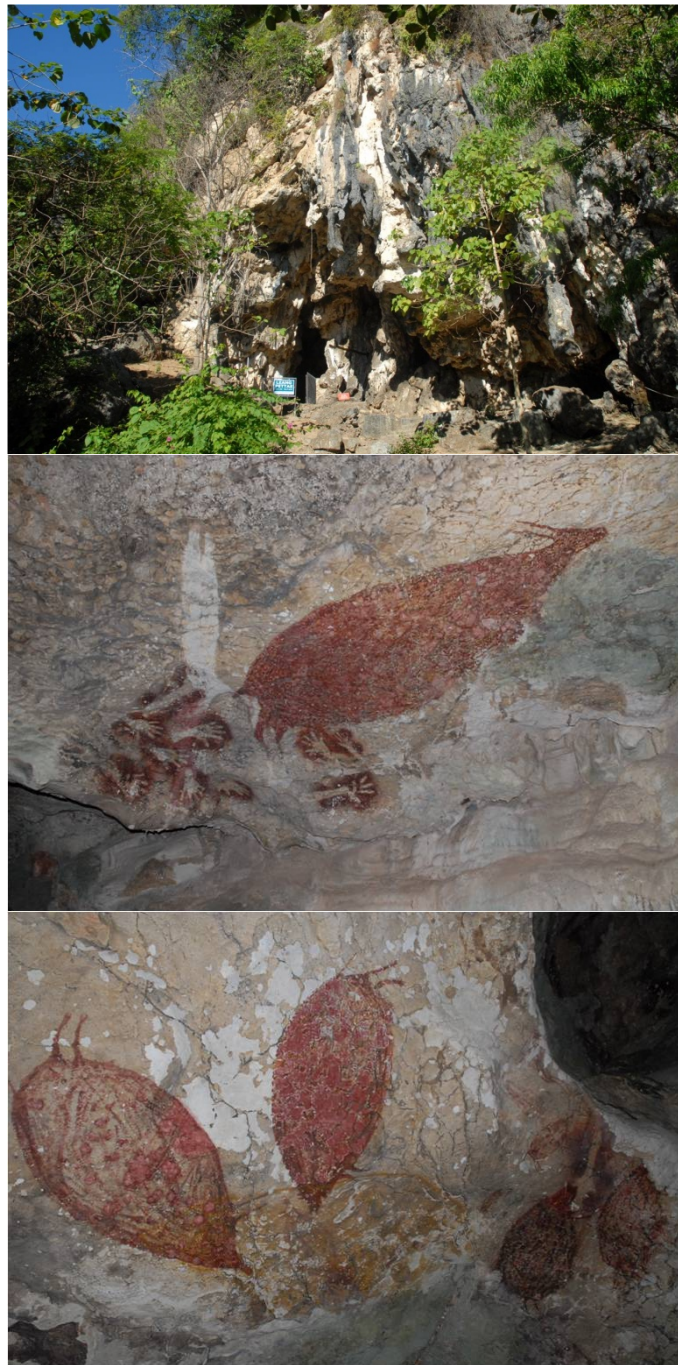
Figure 11. Prehistorical caves in Maros and Pangkep, South Sulawesi  
(documentation of the Borobudur Heritage Conservation Office, Indonesia)
